VILLAGE OF LONGVIEW

INFRASTRUCTURE MANAGEMENT PLAN

Date: May 11, 2017
Project #: 2530-013-00

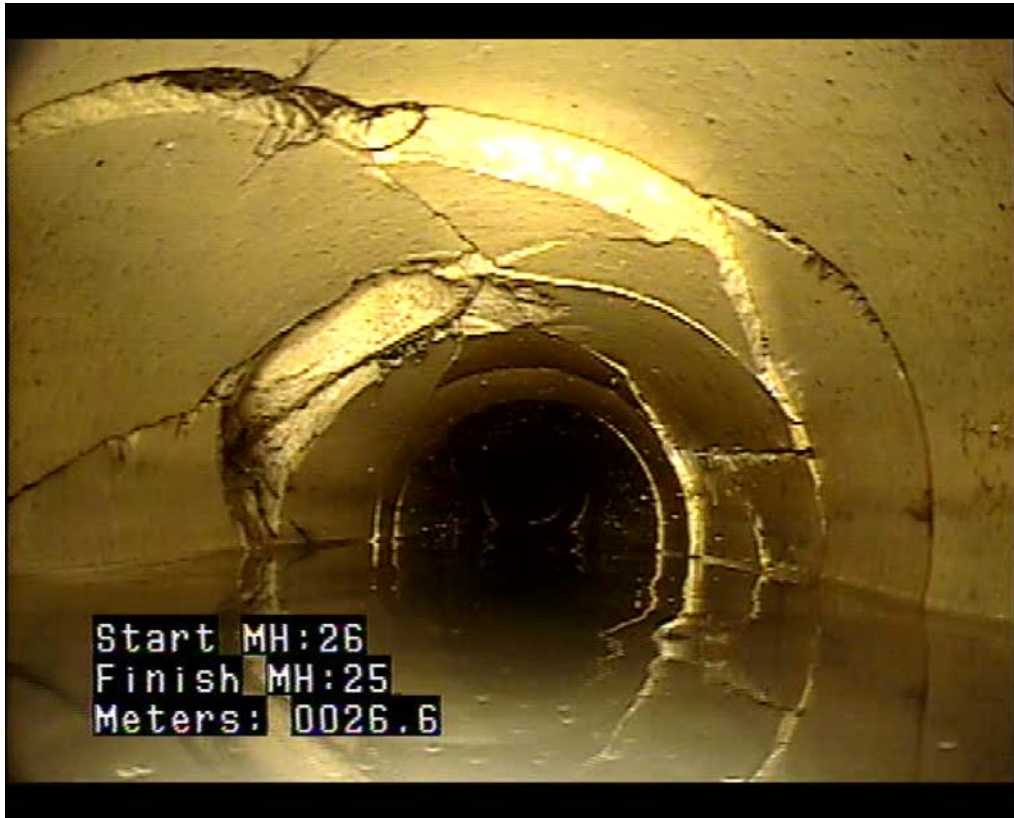
There are three sections of pipe rated as “Poor”. The sections are shown in red on **Figure 2.2** and are labeled as SP 132, 139 and 156. These sections can be found under the streets of Morrison Road, Twin Cities Drive and Little New York Estates. The reason these sections are classified as “Poor” is due to the presence of multiple crack, fractures, high infiltration and pipe sagging.

Photo 5.1: Severe Cracking and Fractures near Service Connection in Twin Cities Drive (SP 139)

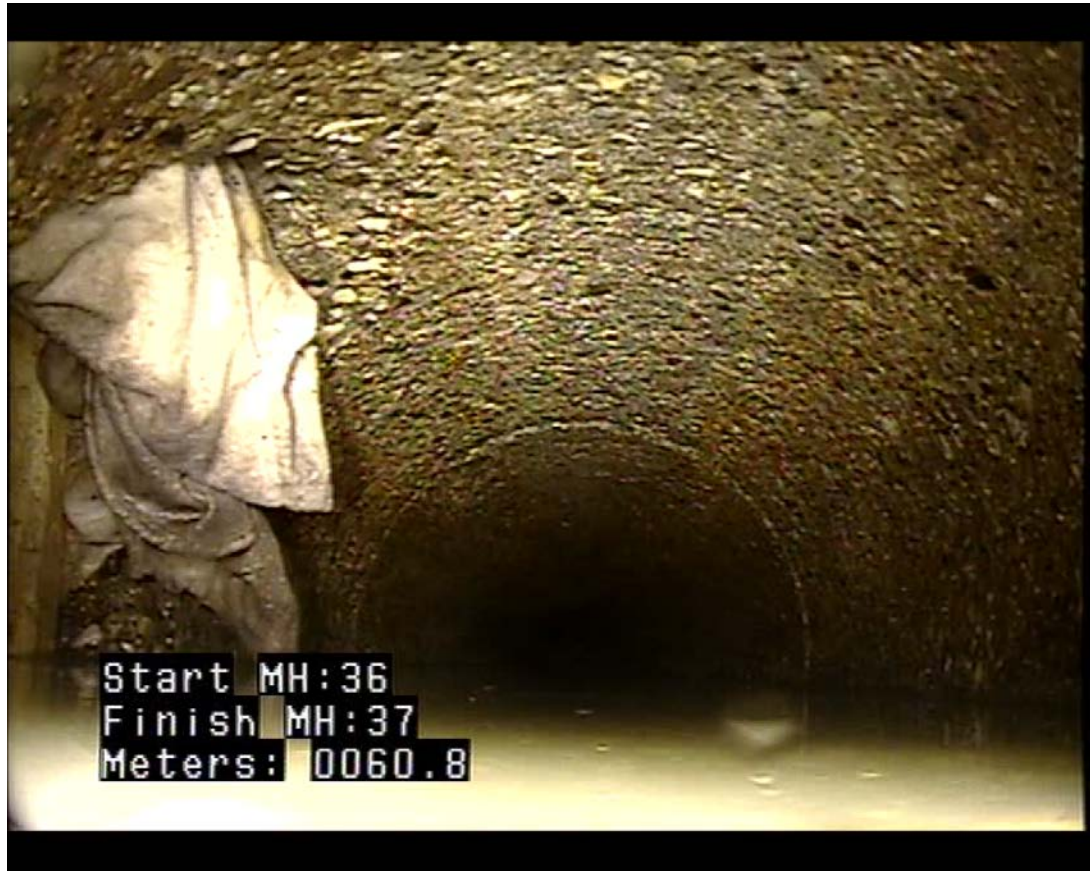
The highest areas of infiltration are seen throughout the concrete piping for Highwood Drive and Riverview Place. From the video inspection, I/I can be seen at several locations where the service pipe connects to the main line. At four locations where the service pipe connects to the main line, a rag is being used as a gasket. Two of these locations are along SP 124, one is along SP 125 and the other is along SP 127. Other sources of I/I were seen along Twin Cities Drive and Morrison Road.

Photo 5.2: Rag Wrapped around Service Pipe in Highwood Drive (SP 125)

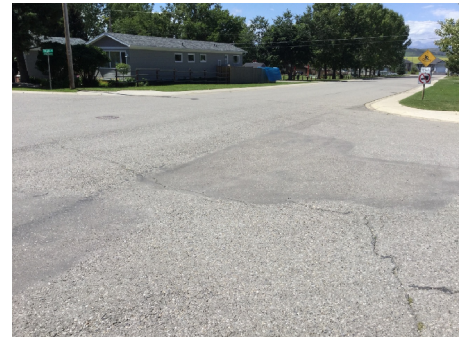
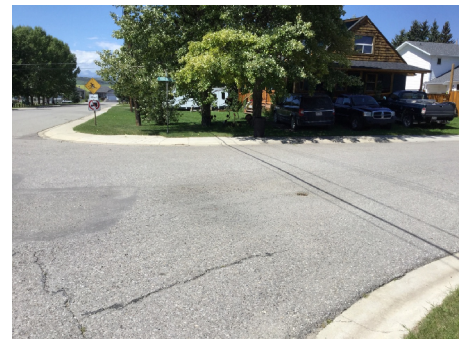
Transverse Cracks	0-5	3
Longitudinal Cracks	0-5	2
Alligator Cracks	0-10	5
Shrinkage Cracks	0-5	3
Rutting	0-10	1
Corrugations	0-5	0
Ravelling	0-5	2
Shoving or Pushing	0-10	0
Pot Holes	0-10	0
Excess Asphalt	0-10	1
Polished Aggregate	0-5	1
Deficient Drainage	0-10	0
Overall Riding Quality (0 is excellent: 10 is very poor)	0-10	4
Sum of Defects:		22
Condition Rating = 100 - Sum of Defects: Condition Rating		78

Other Notes: Attached sidewalk on 1 side of road, moderate damage to curbs/walk 5/10, (moderate to high)

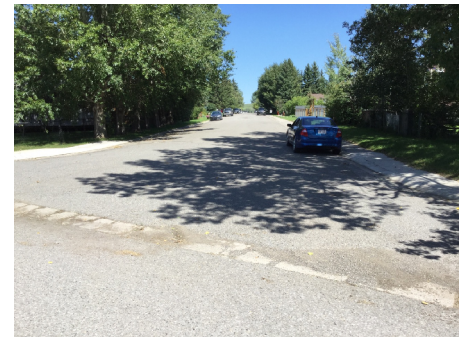
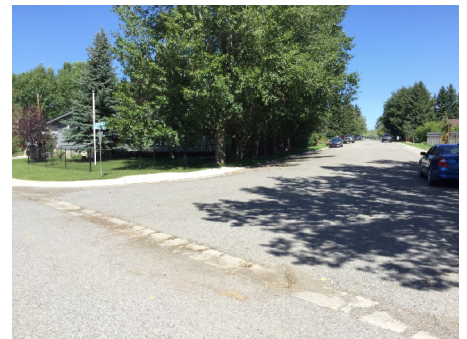
Transverse Cracks	0-5	3
Longitudinal Cracks	0-5	3
Alligator Cracks	0-10	8
Shrinkage Cracks	0-5	2
Rutting	0-10	3
Corrugations	0-5	1
Ravelling	0-5	2
Shoving or Pushing	0-10	1
Pot Holes	0-10	1
Excess Asphalt	0-10	0
Polished Aggregate	0-5	2
Deficient Drainage	0-10	0
Overall Riding Quality (0 is excellent: 10 is very poor)	0-10	6
Sum of Defects:		32
Condition Rating = 100 - Sum of Defects: Condition Rating		68

Other Notes: Attached sidewalk on 1 side of road, curbs and walk in good condition

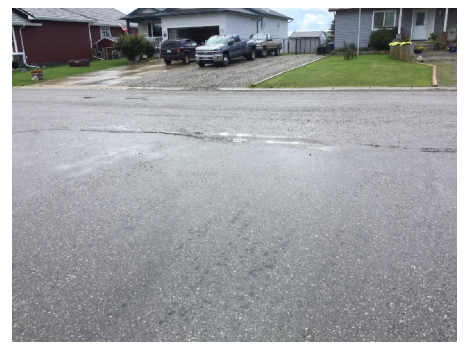
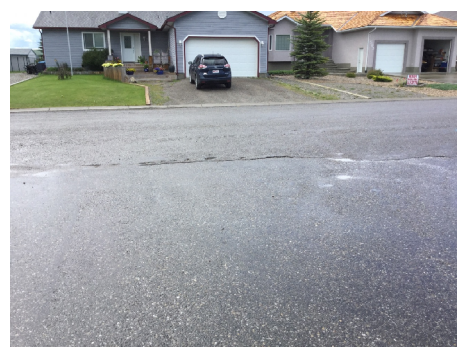
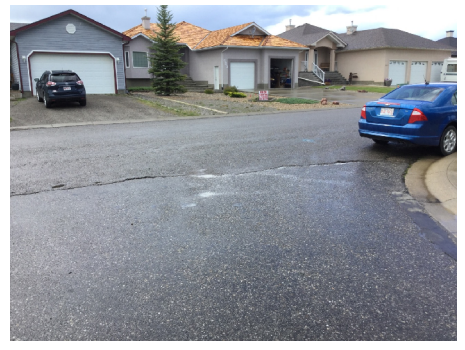
Transverse Cracks	0-5 2
Longitudinal Cracks	0-5 3
Alligator Cracks	0-10 0
Shrinkage Cracks	0-5 1
Rutting	0-10 2
Corrugations	0-5 0
Ravelling	0-5 0
Shoving or Pushing	0-10 0
Pot Holes	0-10 2
Excess Asphalt	0-10 0
Polished Aggregate	0-5 2
Deficient Drainage	0-10 0
Overall Riding Quality (0 is excellent: 10 is very poor)	0-10 0
Sum of Defects: 12
Condition Rating = 100 - Sum of Defects: Condition Rating		88

Other Notes: Attached sidewalk on one side of road , worst area is intersection of Longview and highwood drive
