VILLAGE OF LONGVIEW

INFRASTRUCTURE MANAGEMENT PLAN

Date: May 11, 2017
Project #: 2530-013-00

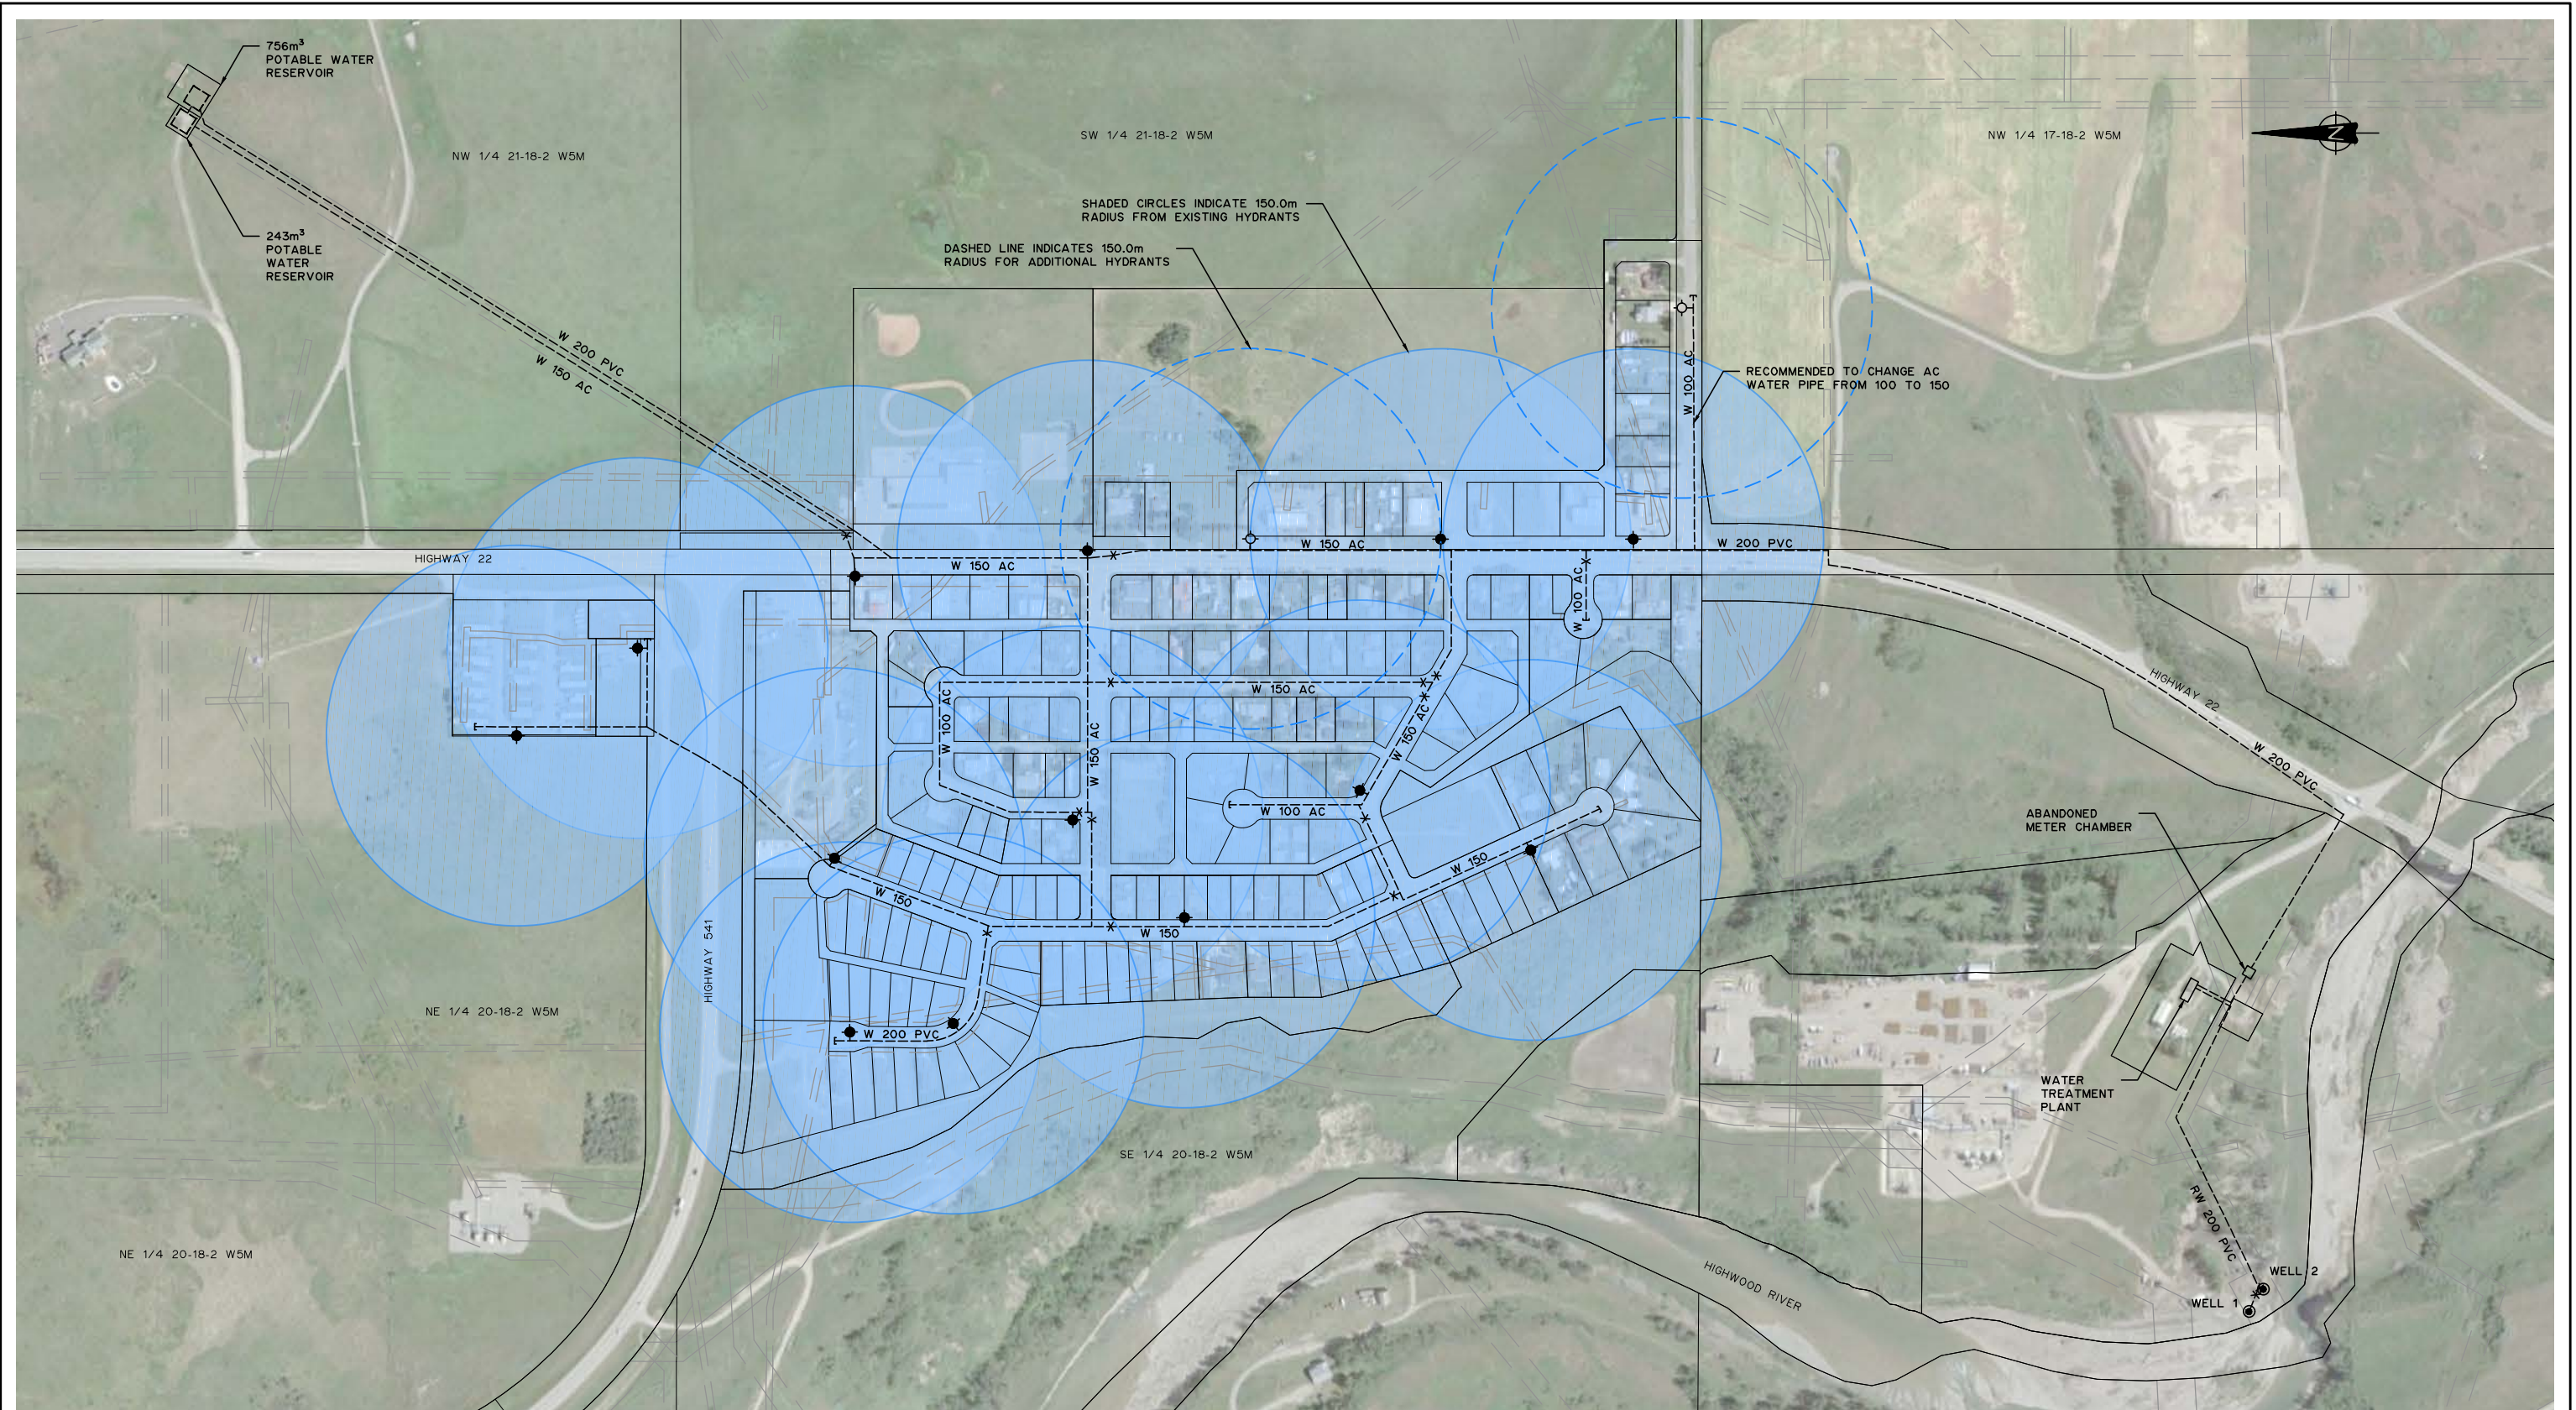
SCALE: 1:5000	DATE: MAY 2017	JOB: 2530-013-00	FIGURE: 1.2
---------------	----------------	------------------	-------------

One additional hydrant is required along the commercial area on Morrison Road, and one on the east end of Kee Drive to meet both the City of Calgary and FUS minimum hydrant spacing. See **Figure 1.2** for hydrant coverage details.

8. Addition of Hydrants: One additional hydrant should be installed along Morrison Road, and another at the east end of Kee Drive to provide adequate coverage as identified on the hydrant map (**Figure 1.2**).

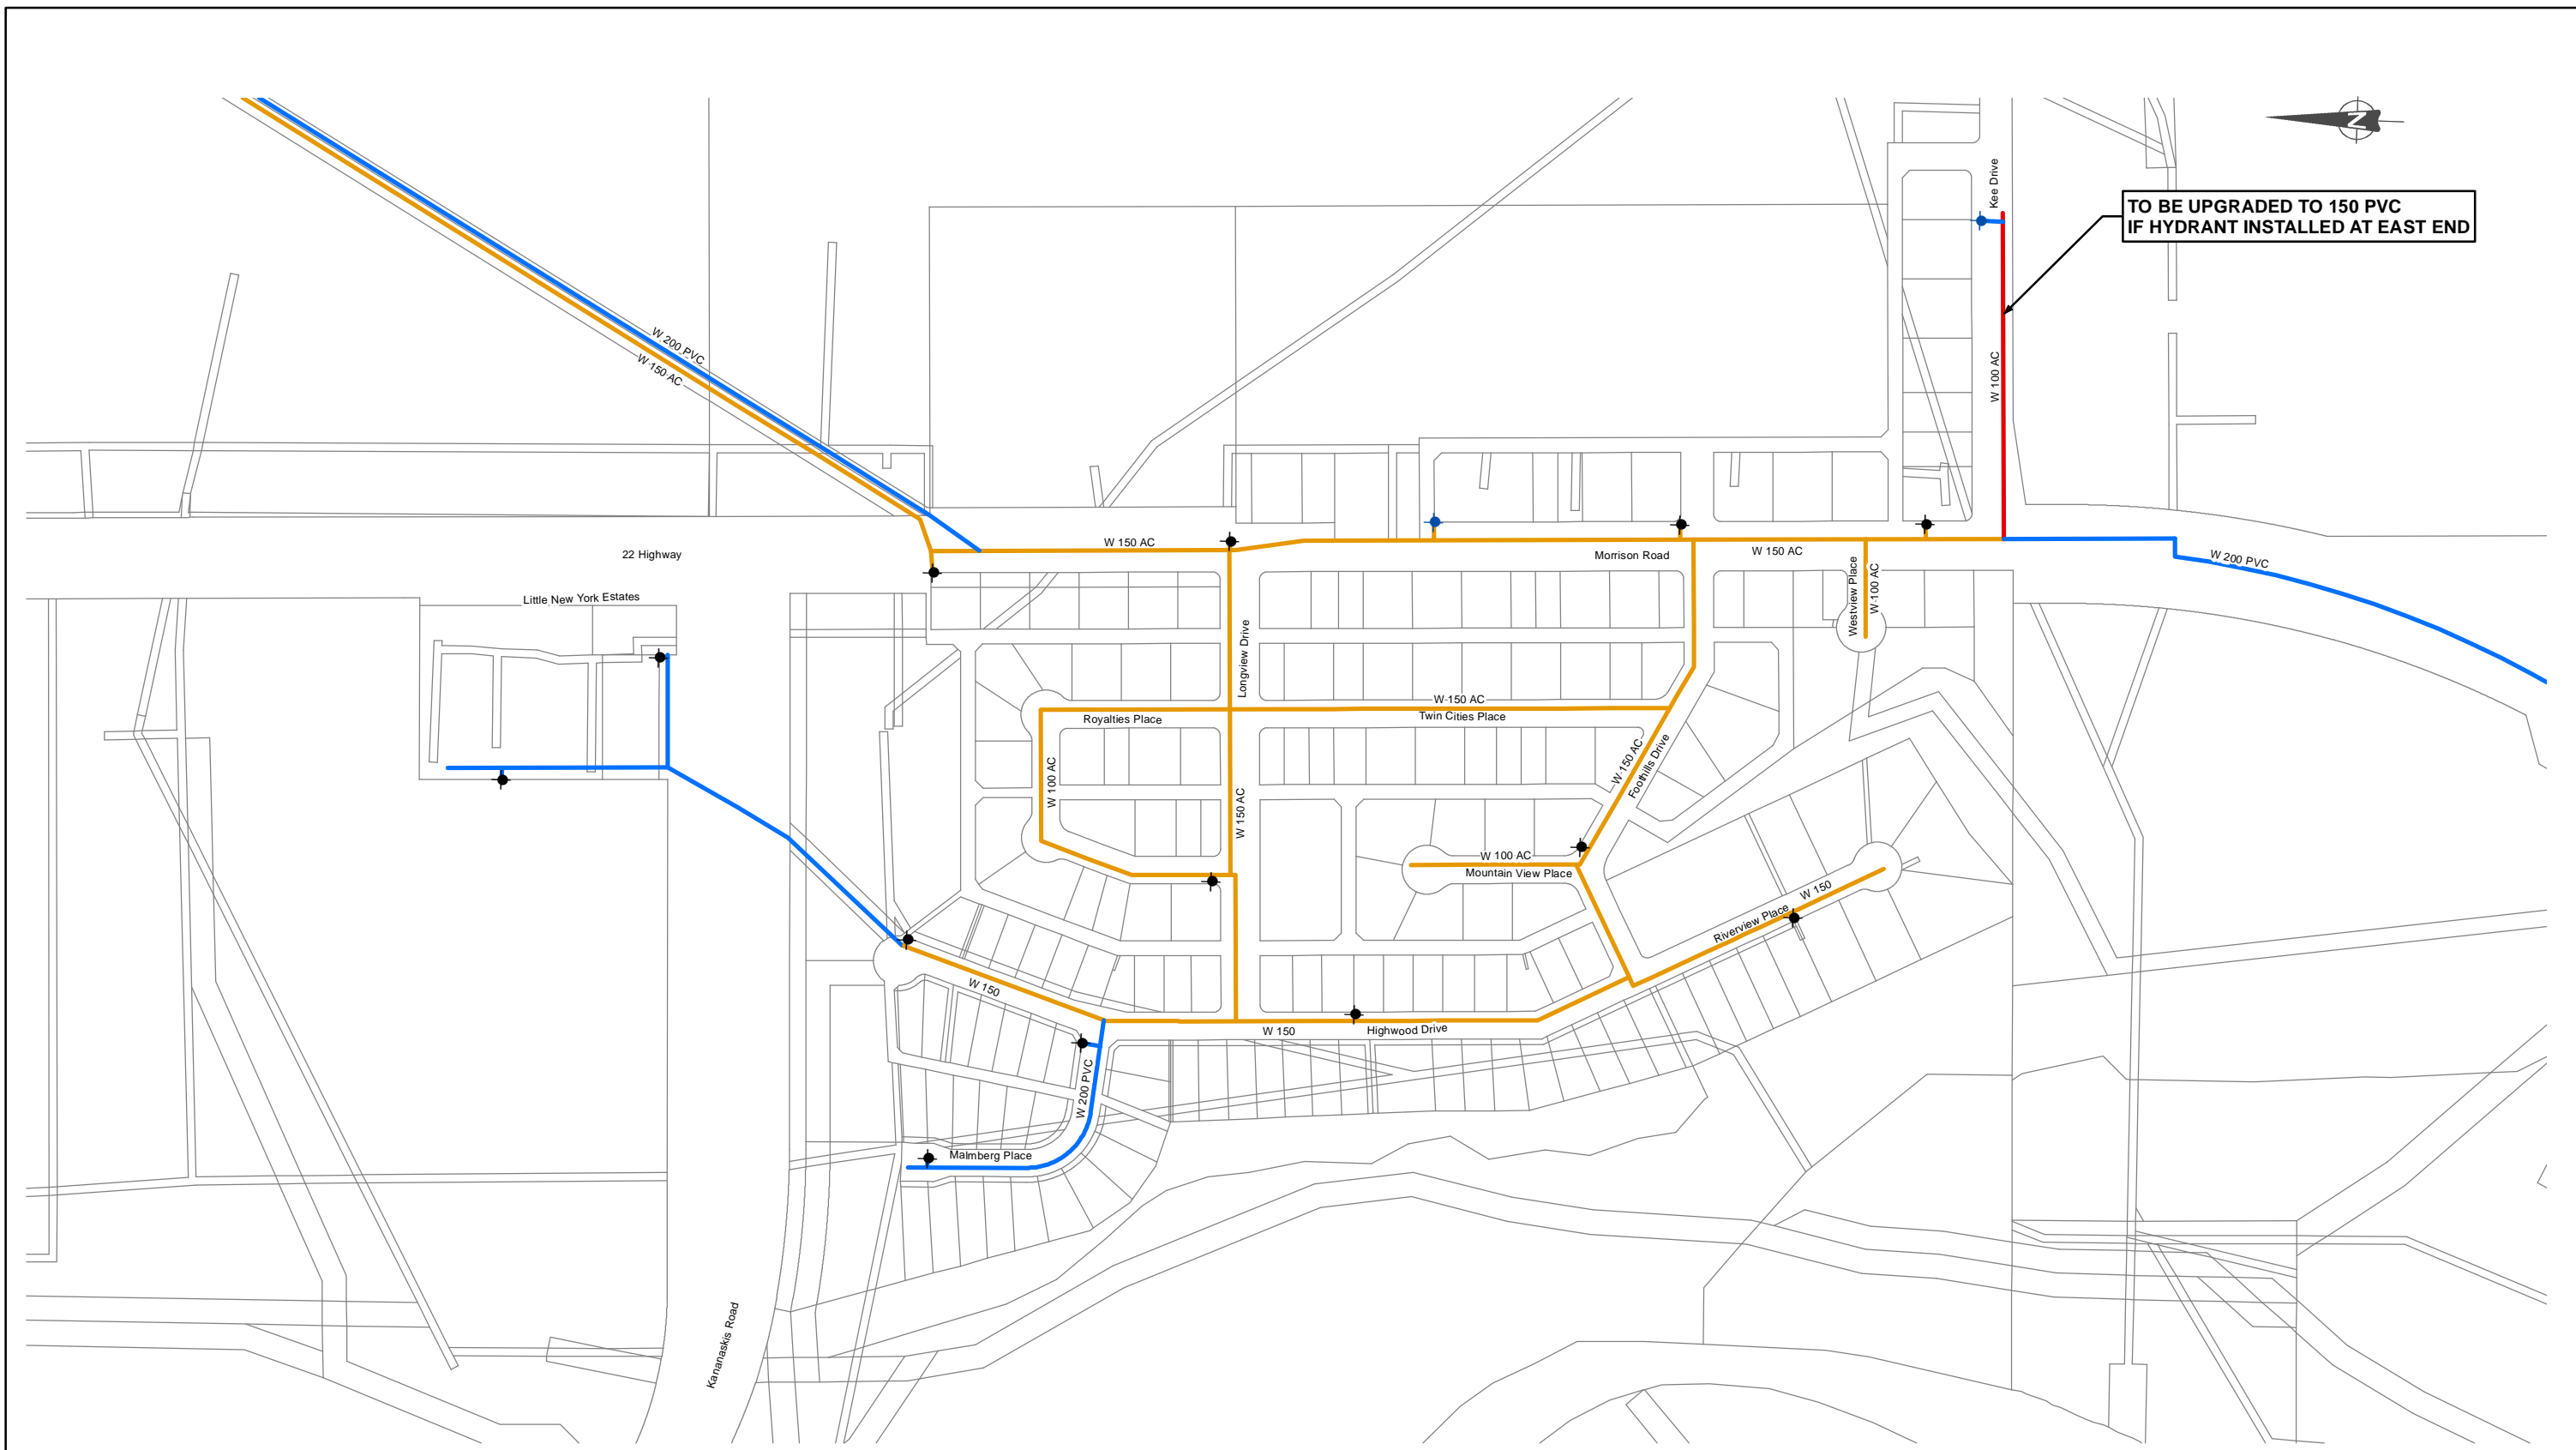
TOWN OF LONGVIEW	
		LONGVIEW INFRASTRUCTURE MANAGEMENT PLAN 2016 WASTEWATER SYSTEM CONDITION RATINGS	
SCALE: 1:4,000	DATE: MAY 2017	JOB: 2530-013-00	FIGURE: 2.2

There are three sections of pipe rated as “Poor”. The sections are shown in red on **Figure 2.2** and are labeled as SP 132, 139 and 156. These sections can be found under the streets of Morrison Road, Twin Cities Drive and Little New York Estates. The reason these sections are classified as “Poor” is due to the presence of multiple crack, fractures, high infiltration and pipe sagging.

1. **Collection Mains:** All lines with a condition rating of sub-standard (4 or 5) are a high priority to be replaced, particularly before any paving program. Isolated wastewater main(s) requiring refurbishment located in areas where no water main work is required or where it is desirable to preserve the existing road surface (such as in Morrison Rd.) the Village should consider relining using cure-in-place in-situ formed lining. The wastewater collection system condition ratings are shown on **Figure 2.2**.

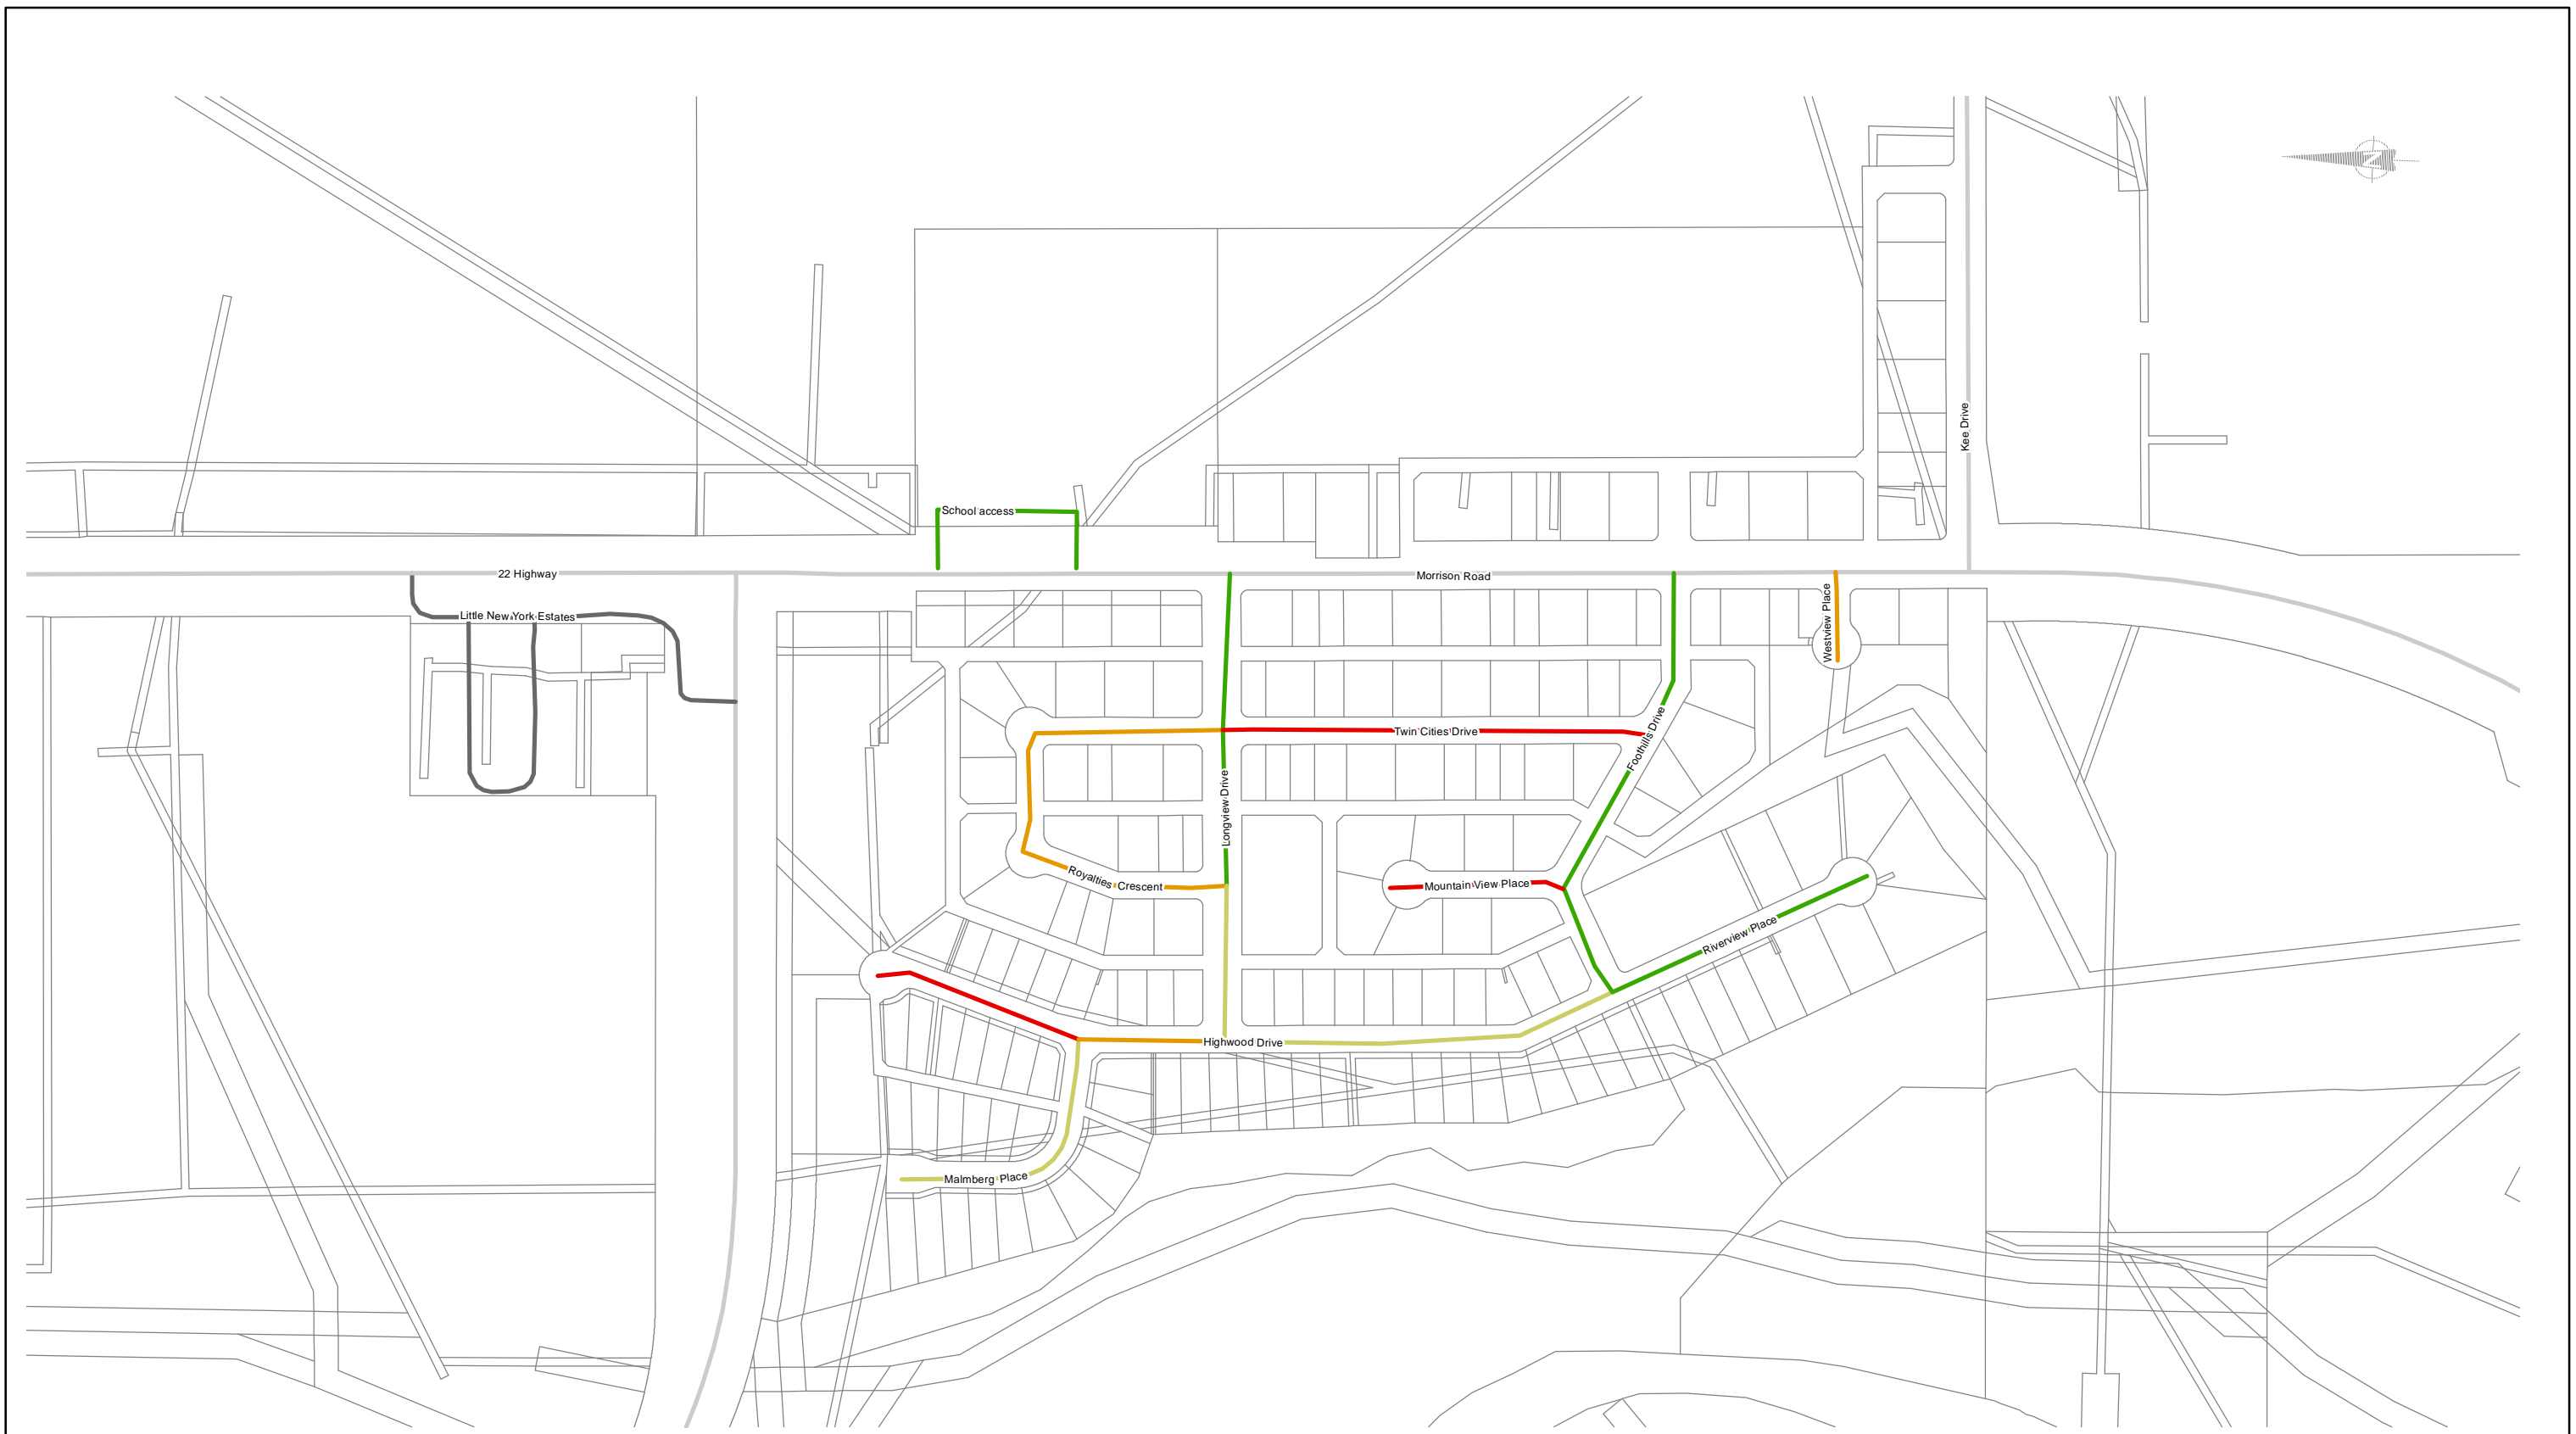
FIGURE: 2.3

1. **High Priority Upgrades**: The roads with condition ratings between 68–71 are in poor condition and should be upgraded within the next five years. Road condition ratings are shown on **Figure 2.3**.
2. **Medium Priority Upgrades**: The roads with a condition rating of 72–89 are in fair to poor condition. These roads should be upgraded within the next five to fifteen years.
3. **Low Priority Upgrades**: These are the road sections that are in reasonably good condition (ratings between 90-99). The condition of these roads should be monitored but there is no expected maintenance within the next fifteen years.

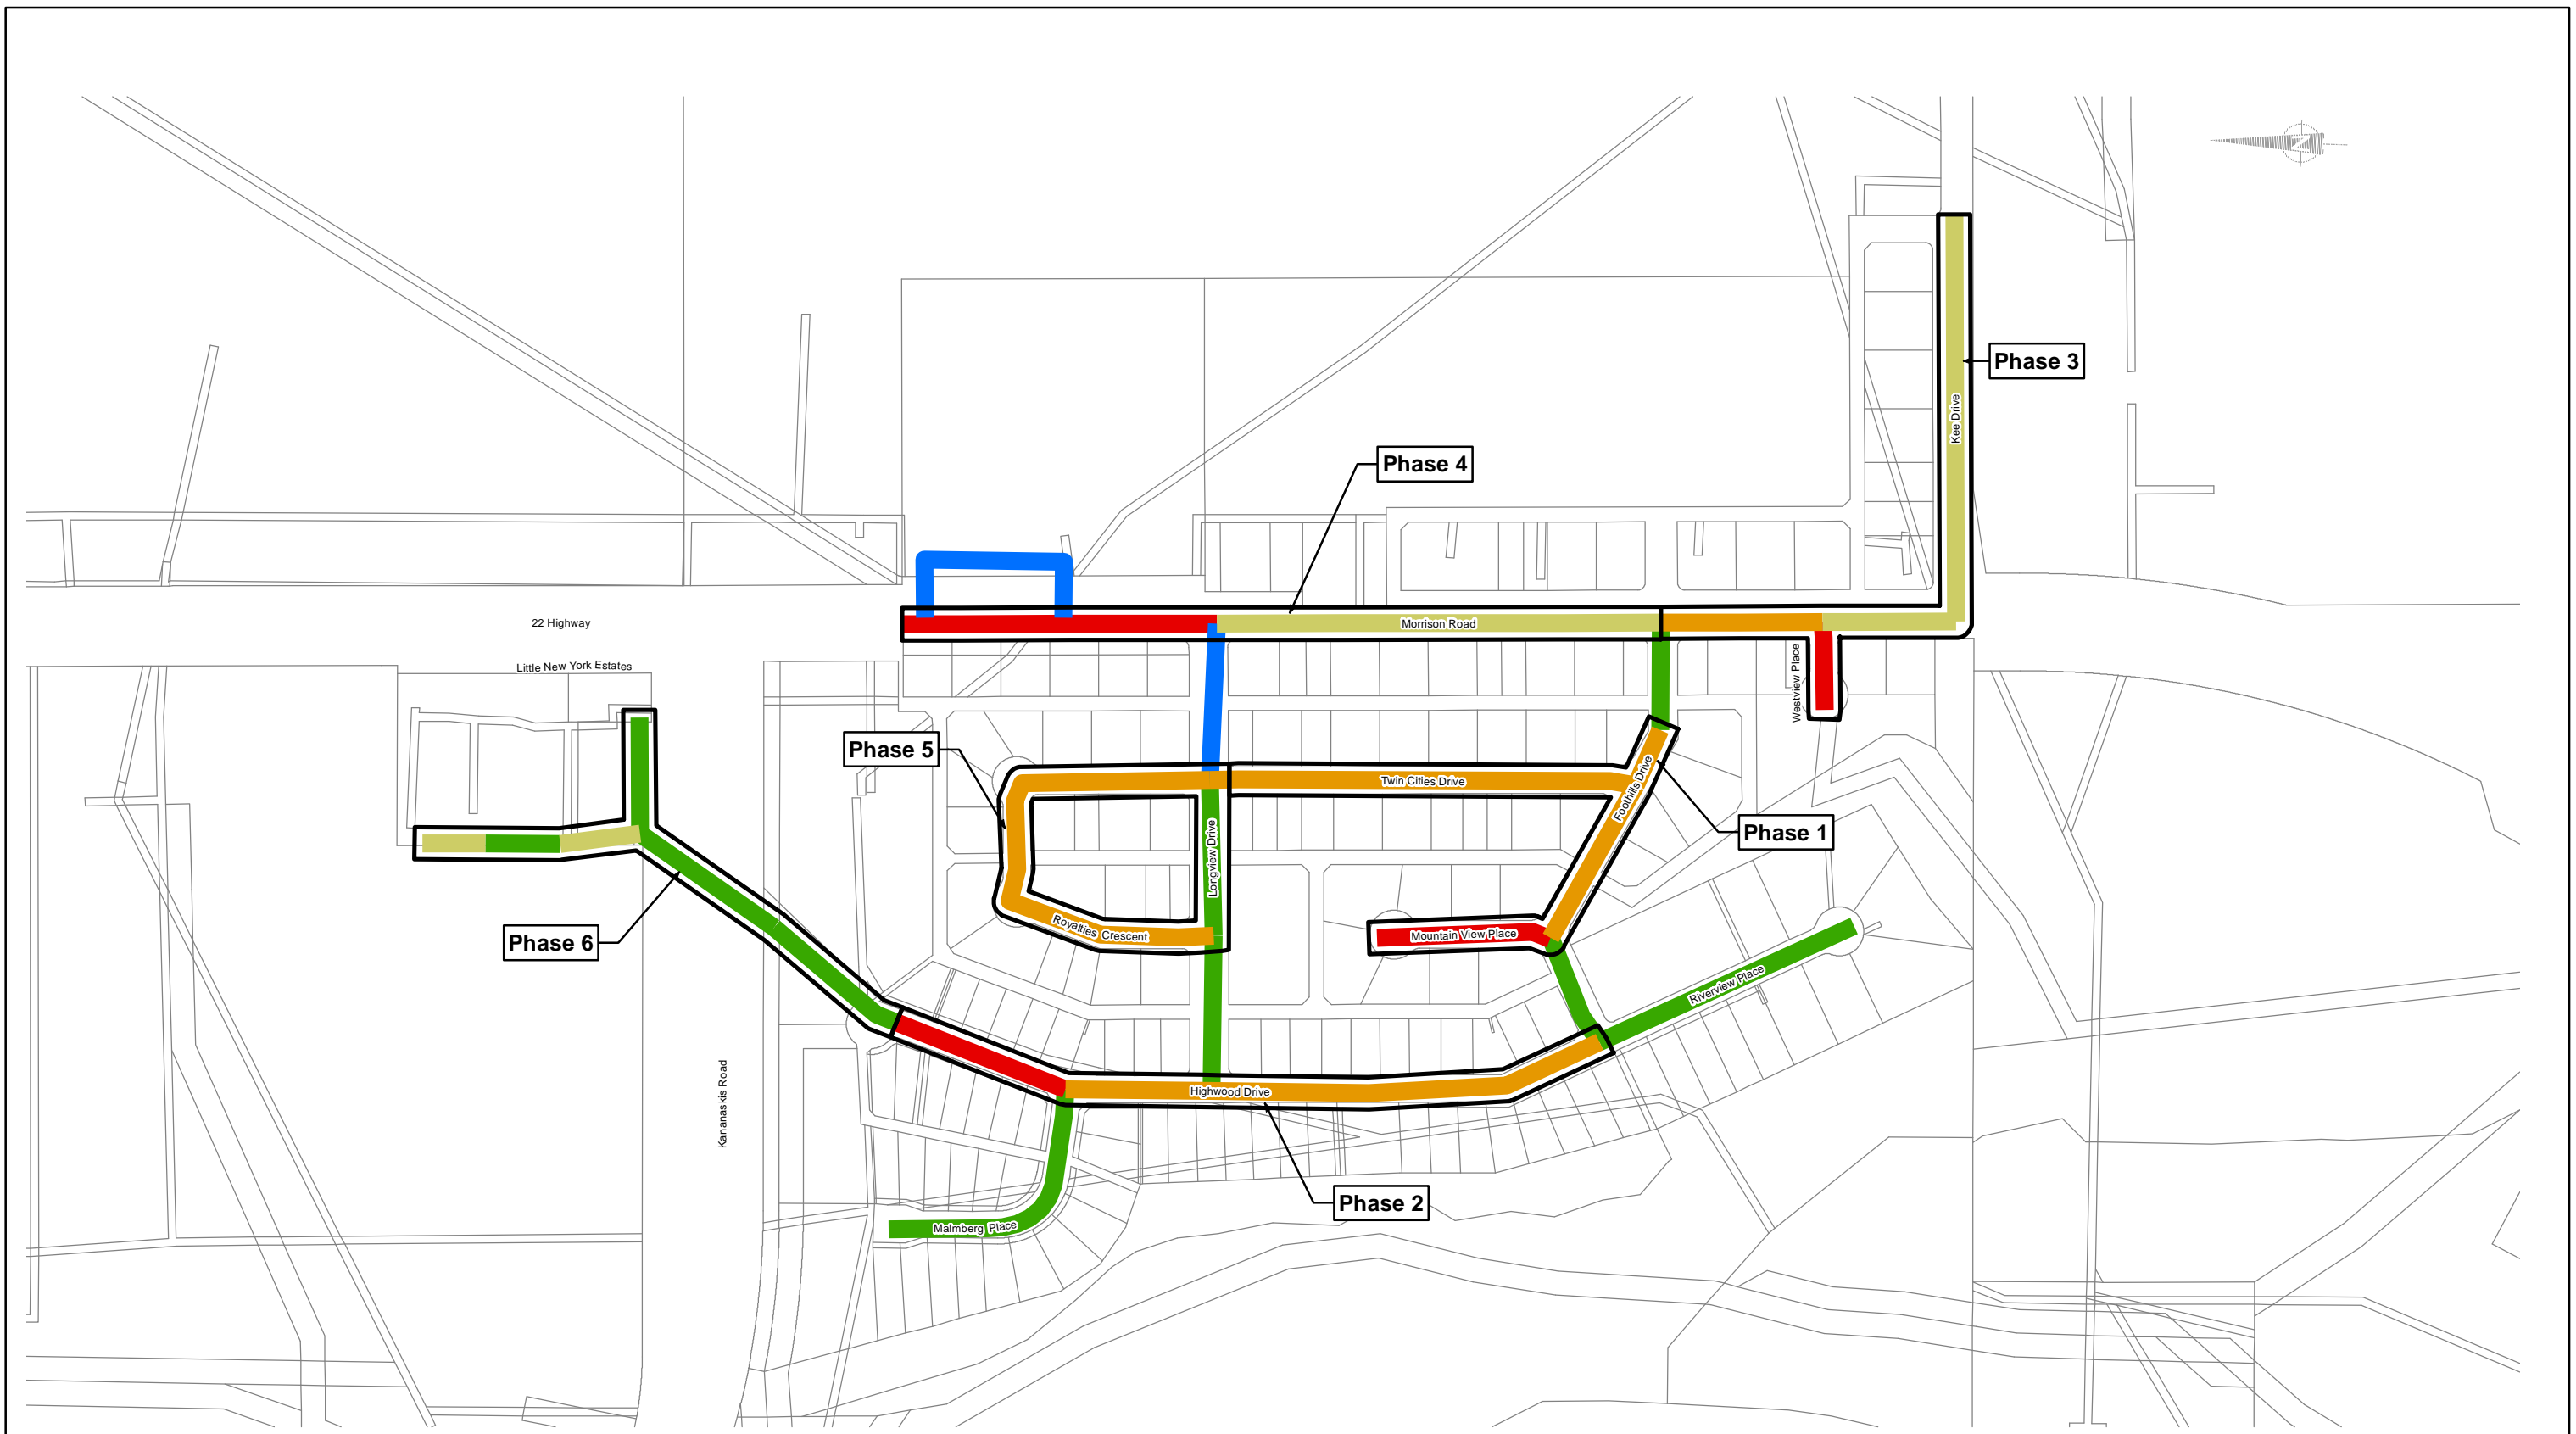
SCALE: 1:4,000	DATE: MAY 2017	JOB: 2530-013-00	FIGURE: 2.4
----------------	----------------	------------------	-------------

The infrastructure projects for the water/wastewater pipeline replacements are based on the separate risk assessments of the road, wastewater and water systems. An overall importance rating for each road/replacement project was calculated, with higher weighting precedence given first to wastewater, then road, then water system upgrades. The suggested replacement projects and combined risk rating are also illustrated in **Figure 2.4**.

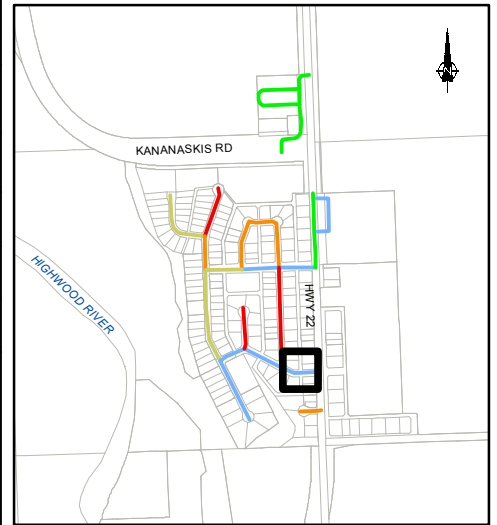
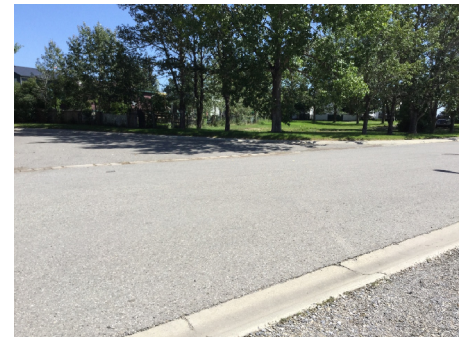
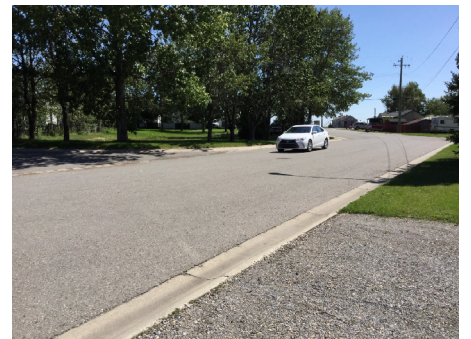
Project:	LONGVIEW IMP	File:	2530-013-00
Road ID:	FOOTHILLS-MORRISON	Location:	Foothills Drive
Pavement:	Length: 105m	Width: 10.5m	Area: 1098m ²
Pavement Type:	Asphalt	Date of Inspection:	August 2016
No. of Manholes Observed:	2	No. of Valves Observed:	2
Replace Sidewalk:	Replace Curb:

Condition Rating = 100 - Sum of Defects: **Condition Rating 93**

Other Notes: Attached sidewalk on one side of road, curbs and walk in good condition

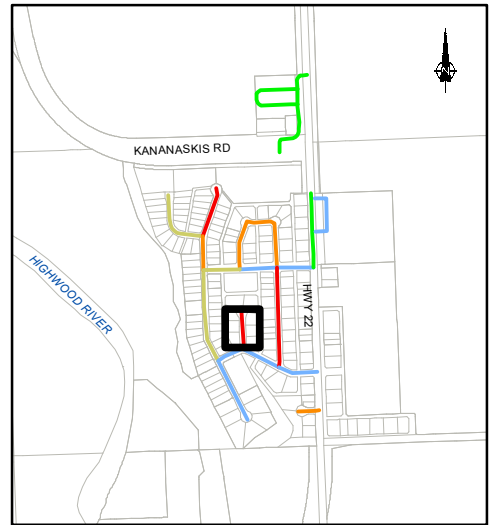
Project:	LONGVIEW IMP	File:	2530-013-00
Road ID:	MOUNTAIN-VIEW	Location:	Mountain View Place
Pavement:	Length: 109m	Width: 10.3m	Area: 1122m ²
Pavement Type:	Asphalt	Date of Inspection:	August 2016
No. of Manholes Observed:	1	No. of Valves Observed:	0
Replace Sidewalk:	Replace Curb:

<u>Defects:</u>	<u>Rating:</u>
Transverse Cracks	0-5 1
Longitudinal Cracks	0-5 1
Alligator Cracks	0-10 2
Shrinkage Cracks	0-5 1
Rutting	0-10 4
Corrugations	0-5 1
Ravelling	0-5 3
Shoving or Pushing	0-10 3
Pot Holes	0-10 2
Excess Asphalt	0-10 4
Polished Aggregate	0-5 3
Deficient Drainage	0-10 0
Overall Riding Quality (0 is excellent: 10 is very poor)	0-10 4
Sum of Defects:	29
Condition Rating = 100 - Sum of Defects: Condition Rating	71

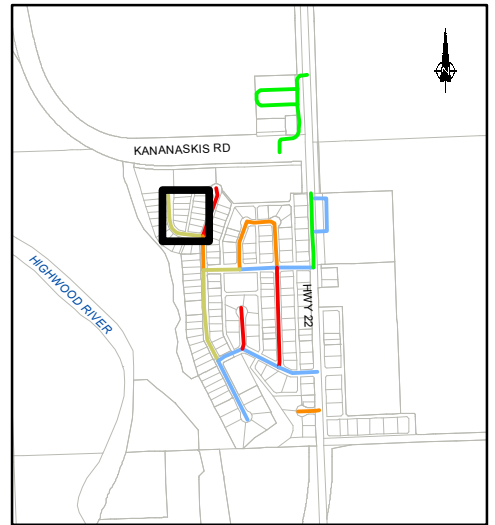
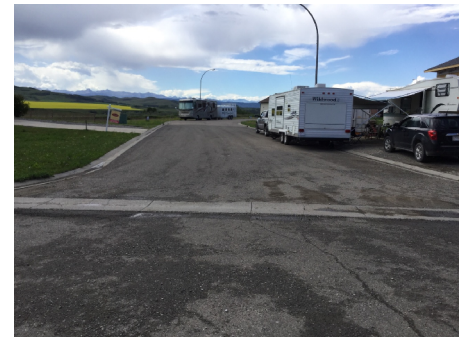
Project:	LONGVIEW IMP	File:	2530-013-00
Road ID:	MALMBERG	Location:	Malmberg Place
Pavement:	Length: 175m	Width: 10.3m	Area: 1807m ²
Pavement Type:	Asphalt	Date of Inspection:	August 2016
No. of Manholes Observed:	2	No. of Valves Observed:	0
Replace Sidewalk:	Replace Curb:

Transverse Cracks	0-5 3
Longitudinal Cracks	0-5 2
Alligator Cracks	0-10 1
Shrinkage Cracks	0-5 3
Rutting	0-10 0
Corrugations	0-5 0
Ravelling	0-5 1
Shoving or Pushing	0-10 0
Pot Holes	0-10 0
Excess Asphalt	0-10 0
Polished Aggregate	0-5 1
Deficient Drainage	0-10 0
Overall Riding Quality (0 is excellent: 10 is very poor)	0-10 0
Sum of Defects: 11
Condition Rating = 100 - Sum of Defects: Condition Rating		89

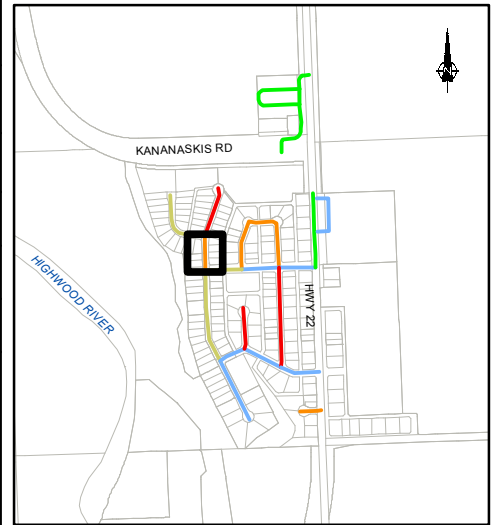
Project:	LONGVIEW IMP	File:	2530-013-00
Road ID:	HIGHWOOD-MALM	Location:	Highwood Drive
Pavement:	Length: 91m	Width: 10.3m	Area: 937m ²
Pavement Type:	Asphalt	Date of Inspection:	August 2016
No. of Manholes Observed:	1	No. of Valves Observed:	1
Replace Sidewalk:	Replace Curb:

Transverse Cracks	0-5 4
Longitudinal Cracks	0-5 2
Alligator Cracks	0-10 2
Shrinkage Cracks	0-5 2
Rutting	0-10 1
Corrugations	0-5 1
Ravelling	0-5 1
Shoving or Pushing	0-10 0
Pot Holes	0-10 1
Excess Asphalt	0-10 1
Polished Aggregate	0-5 2
Deficient Drainage	0-10 0
Overall Riding Quality (0 is excellent: 10 is very poor)	0-10 0
Sum of Defects: 17
Condition Rating = 100 - Sum of Defects: Condition Rating		83

Other Notes: Minor damage to curbs and sidewalks , sidewalk on east side of road only

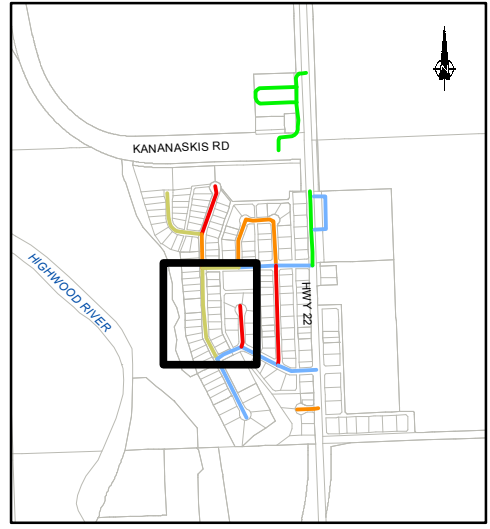
Project:	LONGVIEW IMP	File:	2530-013-00
Road ID:	HIGHWOOD-LONGVIEW	Location:	Highwood Drive
Pavement:	Length: 248m	Width: 10.3m	Area: 2558m ²
Pavement Type:	Asphalt	Date of Inspection:	August 2016
No. of Manholes Observed:	2	No. of Valves Observed:	2
Replace Sidewalk:	Replace Curb:

Transverse Cracks	0-5 2
Longitudinal Cracks	0-5 3
Alligator Cracks	0-10 0
Shrinkage Cracks	0-5 1
Rutting	0-10 2
Corrugations	0-5 0
Ravelling	0-5 0
Shoving or Pushing	0-10 0
Pot Holes	0-10 2
Excess Asphalt	0-10 0
Polished Aggregate	0-5 2
Deficient Drainage	0-10 0
Overall Riding Quality (0 is excellent: 10 is very poor)	0-10 0
Sum of Defects: 12
Condition Rating = 100 - Sum of Defects: Condition Rating		88

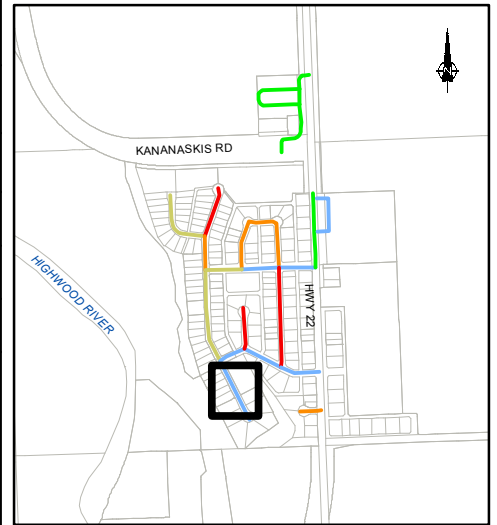
Project:	LONGVIEW IMP	File:	2530-013-00
Road ID:	RIVERVIEW-FOOTHILLS	Location:	Riverview Place
Pavement:	Length: 174m	Width: 10.3m	Area: 1796m ²
Pavement Type:	Asphalt	Date of Inspection:	August 2016
No. of Manholes Observed:	4	No. of Valves Observed:	0
Replace Sidewalk:	Replace Curb:

Transverse Cracks	0-5 2
Longitudinal Cracks	0-5 2
Alligator Cracks	0-10 1
Shrinkage Cracks	0-5 0
Rutting	0-10 0
Corrugations	0-5 0
Ravelling	0-5 0
Shoving or Pushing	0-10 0
Pot Holes	0-10 0
Excess Asphalt	0-10 0
Polished Aggregate	0-5 0
Deficient Drainage	0-10 0
Overall Riding Quality (0 is excellent: 10 is very poor)	0-10 0
Sum of Defects: 5
Condition Rating = 100 - Sum of Defects: Condition Rating		95

Other Notes: 3 Sani mh ,1 storm , portion south of LS gravel road has been replaced recently

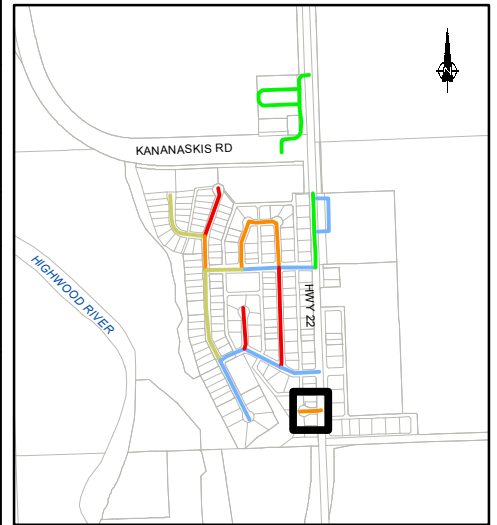
Project:	LONGVIEW IMP	File:	2530-013-00
Road ID:	WESTVIEW	Location:	Westview Place
Pavement:	Length: 55m	Width: 8.4m	Area: 462m ²
Pavement Type:	Asphalt	Date of Inspection:	August 2016
No. of Manholes Observed:	1	No. of Valves Observed:	1
Replace Sidewalk:	Replace Curb:

Transverse Cracks	0-5 2
Longitudinal Cracks	0-5 1
Alligator Cracks	0-10 1
Shrinkage Cracks	0-5 2
Rutting	0-10 2
Corrugations	0-5 0
Ravelling	0-5 1
Shoving or Pushing	0-10 2
Pot Holes	0-10 0
Excess Asphalt	0-10 0
Polished Aggregate	0-5 0
Deficient Drainage	0-10 1
Overall Riding Quality (0 is excellent: 10 is very poor)	0-10 4
Sum of Defects: 16
Condition Rating = 100 - Sum of Defects: Condition Rating		84
